Quality Assurance and Source Inspection

Contract #: 04-0120F4Cty: SF/ALA Rte: 80 PM: 13.2/13.9File #: 1.28**WELDING INSPECTION REPORT****Resident Engineer:** Casey, William**Address:** 333 Burma Road**City:** Oakland, CA 94607**Report No:** WIR-029502**Date Inspected:** 05-May-2013**Project Name:** SAS Superstructure**OSM Arrival Time:** 700**Prime Contractor:** American Bridge/Fluor Enterprises, a JV**OSM Departure Time:** 1530**Contractor:** American Bridge/Fluor Enterprises, a JV**Location:** Job Site**CWI Name:** N/A**CWI Present:** Yes No**Inspected CWI report:** Yes No N/A**Rod Oven in Use:** Yes No N/A**Electrode to specification:** Yes No N/A**Weld Procedures Followed:** Yes No N/A**Qualified Welders:** Yes No N/A**Verified Joint Fit-up:** Yes No N/A**Approved Drawings:** Yes No N/A**Approved WPS:** Yes No N/A**Delayed / Cancelled:** Yes No N/A**Bridge No:** 34-0006**Component:** SAS OBG**Summary of Items Observed:**

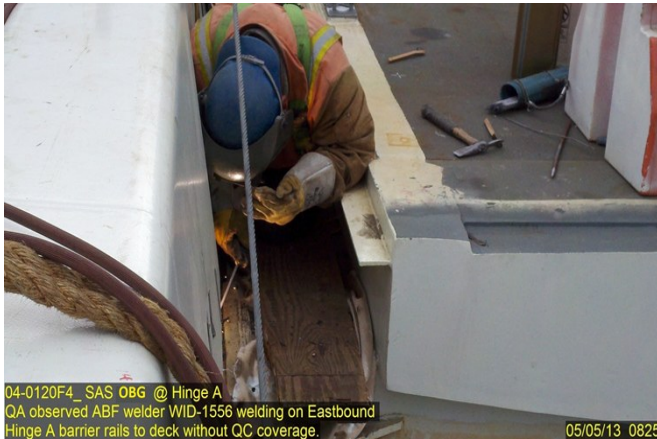
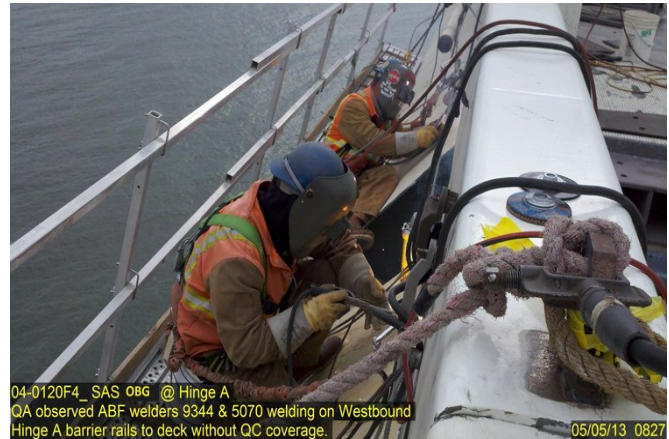
The QA Inspector randomly observed ABF welders Lin E Yun (WID#-9344) & Earl Clayborn (WID#-5070) performing Shielded Metal Arc Welding (SMAW) on West approach barrier rails to OBG at Hinge A (North side). The welders were observed preheating the welds prior to welding with a gas torches. The QA Inspector inquired with the welders if ABF QC had verified the welding parameters prior to commencing the work. The welders had stated that QC was not present at the start of welding and were instructed by ABF personnel to perform the work and in the absence of QC. The welders were observed performing SMAW 2G welding utilizing WPS ABF-D1.5-SMAW-1072. The welding parameters as observed by the QA Inspector appeared to be in compliance with the Welding Procedure Specification (WPS) noted above.

The QA Inspector randomly observed ABF welder Guo Wu Chen (WID#-1556) performing SMAW on the East approach barrier rails to OBG at Hinge A (South side). The QA Inspector also inquired with Mr. Chen if ABF QC had been monitoring the welding parameters prior to commencing the work. Mr. Chen also replied that QC was not present. The welder was observed preheating the welds prior to welding with a gas torch and verifying heat with a temperature indicator. The welder was also observed performing SMAW 2G welding utilizing WPS ABF-D1.5-SMAW-1072. The welding parameters as observed by the QA Inspector appeared to be in compliance with the WPS noted above. The work continued through-out the shift and the barrier rails welds are still in process.

*On this date, the QA Inspector did not observe ABF Quality Control Inspectors present to monitor the welding operations of the contractor as required by contract. Per section 8-3.1 of the Special Provisions-“QC inspections shall be provided to ensure continuous inspection when any welding is being performed”. The QA Inspector notified QA Lead Inspector Scott Croft of the welding in non-compliance on the barrier rails. Mr. Croft informed ABF Welding QC Manager Jim Bowers and SMR Bahjat Dagher of the issue. The QA Inspector was requested by Mr. Dagher to monitor the welding on this shift to ensure that no additional issues may arise on the shift. Please see TL-15 (Incident Report) for additional information on the welding in non-compliance observed on this date.
